Attachment 4 Photos

Attachment 6 Facility Documentation

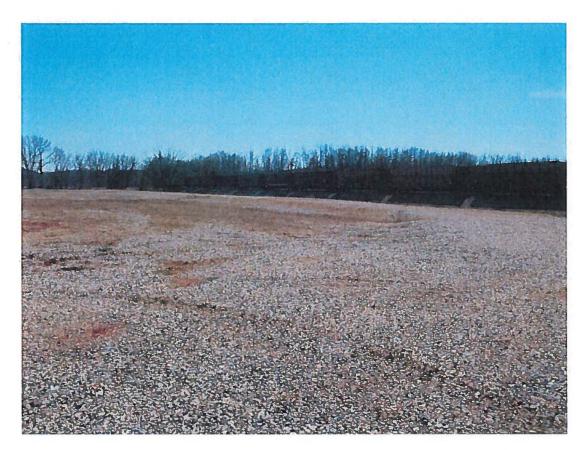
Photo: # 5 Site: Coastal Energy Corp., Willow Springs, MO Date: 3/18/2014 Time: PM Direction: Southeast Photographer: Paul Doherty, EPA Witness: Gary Picard, Coastal Energy Corp. Description: View of the main rail line running along the west side of the property. The rail bed is considered part of the five foot containment berm for the asphalt tanks and loading racks. The effectiveness of railroad bed

ballast as a containment berm material is questionable.

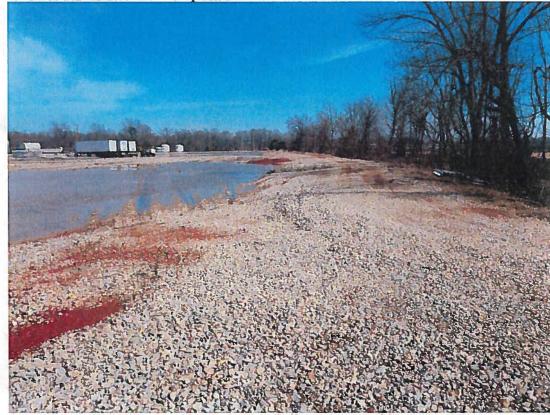
Photo: # 6 Site: Coastal Energy Corp., Willow Springs, MO Date: 3/18/2014 Time: PM Direction: East Photographer: Paul Doherty, EPA Witness: Gary Picard, Coastal Energy Corp. Description: View of the "berm" along the south side of the property. There is a noticeable swale at the edge before the slope drops off into an adjacent creek. The elevation change is less than 2 feet, rather than 5 feet.

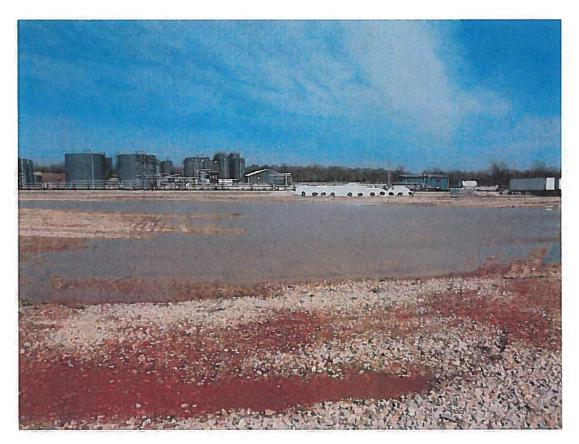
Photo: #7 Site: Coastal Energy Corp., Willow Springs, MO Date: 3/18/2014 Time: PM Direction: North Photographer: Paul Doherty, EPA Witness: Gary Picard, Coastal Energy Corp. Description: View of the graveled area where drainage water is land applied under a state discharge permit. Thy area is described as secondary containment for the asphalt tanks and loading racks.

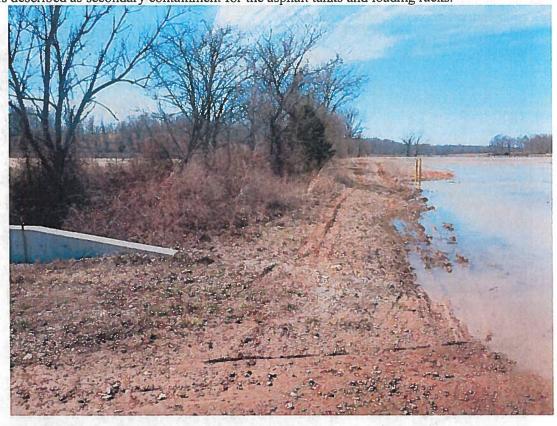
Photo: #8 Site: Coastal Energy Corp., Willow Springs, MO Date: 3/18/2014 Time: PM Direction: West Photographer: Paul Doherty, EPA Witness: Gary Picard, Coastal Energy Corp. Description: View of the service road that crosses the creek at the southeast end of the facility. There is no discernible berm in the area that would prevent runoff from draining into the creek.

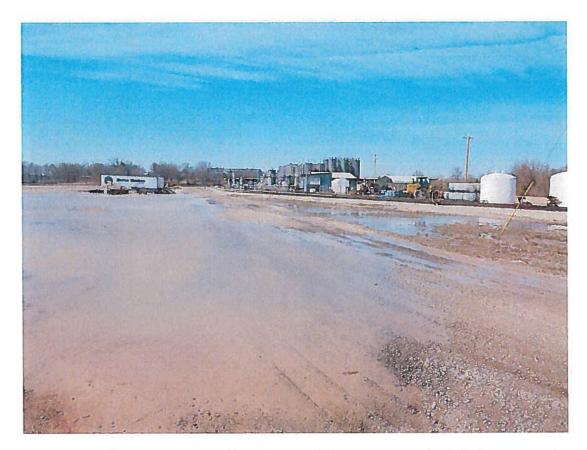
Photo: # 9 Site: Coastal Energy Corp., Willow Springs, MO Date: 3/18/2014 Time: PM Direction: Northwest Photographer: Paul Doherty, EPA Witness: Gary Picard, Coastal Energy Corp. Description: View of the facility from the southeast corner of the property by the service road creek crossing.

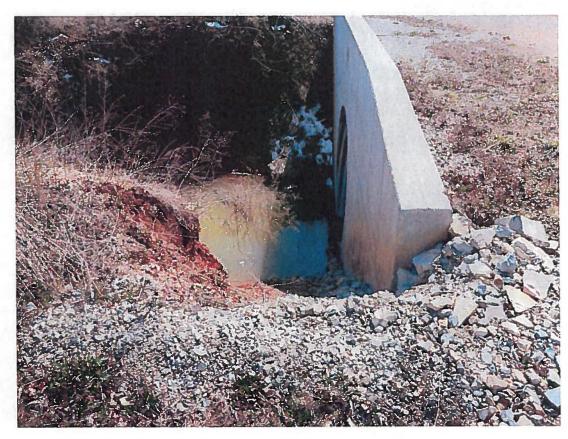
Photo: #10 Site: Coastal Energy Corp., Willow Springs, MO Date: 3/18/2014 Time: PM Direction: South Photographer: Paul Doherty, EPA Witness: Gary Picard, Coastal Energy Corp. Description: View of erosion at the southeast service road creek crossing. No berm is present to prevent the erosion from occurring.

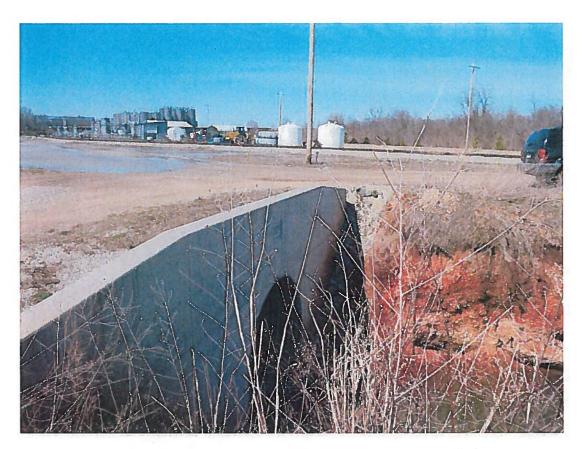
Photo: #11 Site: Coastal Energy Corp., Willow Springs, MO Date: 3/18/2014 Time: PM Direction: Northwest Photographer: Paul Doherty, EPA Witness: Gary Picard, Coastal Energy Corp. Description: View of erosion at the southeast service road creek crossing looking northwest back towards the loading racks and the creek.

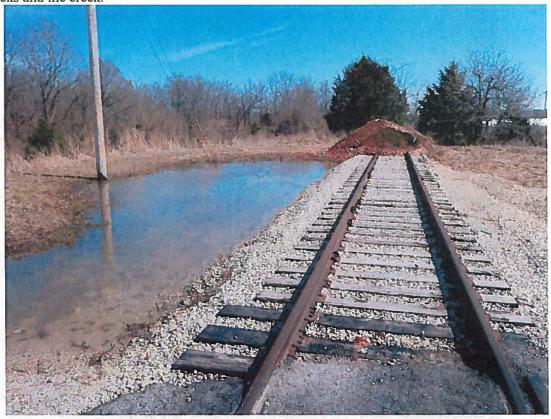
Photo: # 12 Site: Coastal Energy Corp., Willow Springs, MO Date: 3/18/2014 Time: PM Direction: Southeast Photographer: Paul Doherty, EPA Witness: Gary Picard, Coastal Energy Corp. Description: View of the end of the rail spur. No berm separates the southeast end of the property and the Eleven Point River, to the left.

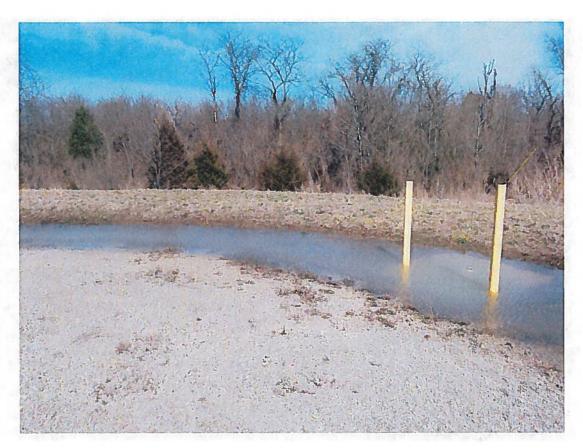
Photo: # 13 Site: Coastal Energy Corp., Willow Springs, MO Date: 3/18/2014 Time: PM Direction: Northeast Photographer: Paul Doherty, EPA Witness: Gary Picard, Coastal Energy Corp. Description: View of the bank of the Eleven Point River along the southeast edge of the property. A noticeable swale is present but not the described 5 foot berm.

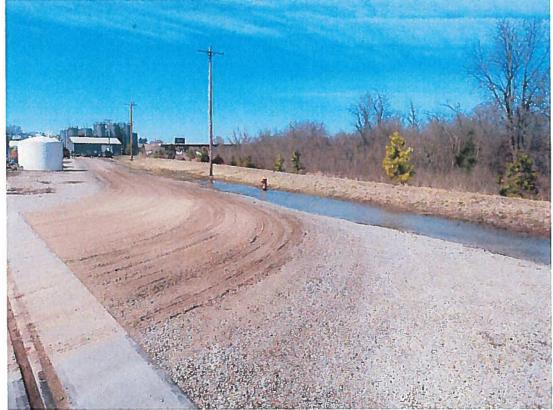
Photo: # 14 Site: Coastal Energy Corp., Willow Springs, MO Date: 3/18/2014 Time: PM Direction: Northwest Photographer: Paul Doherty, EPA Witness: Gary Picard, Coastal Energy Corp. Description: View of the swale that runs along the east side of the property that separates the facility from the Eleven Point River. To describe the swale as a 5 foot berm is inaccurate.

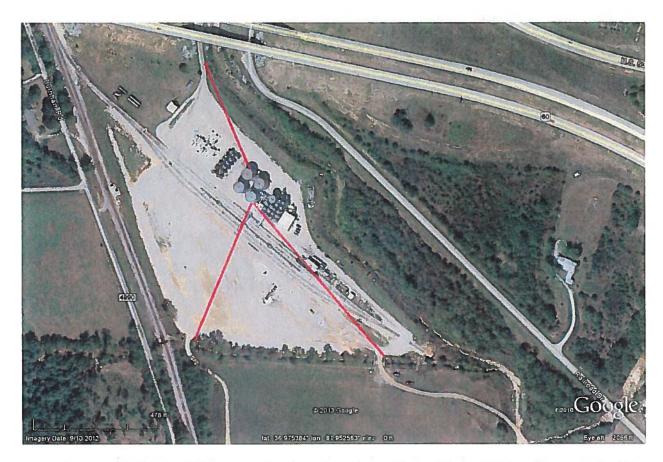
Aerial view of facility and possible flow paths for surface drainage to reach jurisdictional surface water.

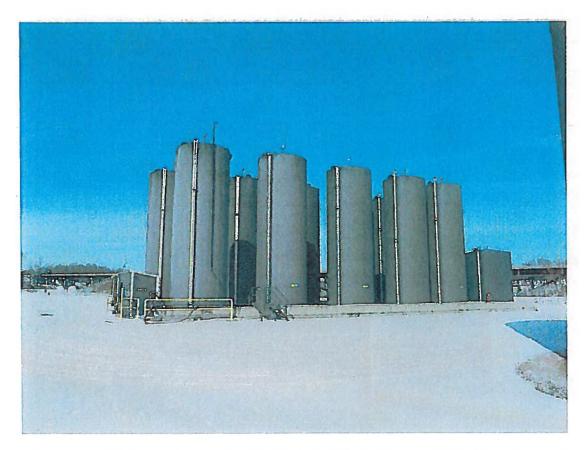
Photo: # 1 Site: Coastal Energy Corp., Willow Springs, MO Date: 2/10/2014 Time: AM Direction: Southeast Photographer: Paul Doherty, EPA Witness: Heath Smith, EPA Description: Coastal Energy Corp. (CEC) ethanol tanks inside secondary containment.

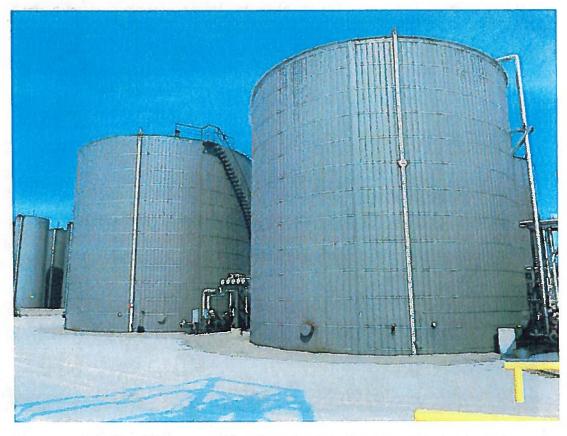
Photo: #2 Site: Coastal Energy Corp., Willow Springs, MO Date: 2/10/2014 Time: AM Direction: North Photographer: Paul Doherty, EPA Witness: Heath Smith, EPA Description: (15) Asphalt tanks (~2.3 million gallons) not contained within sized secondary containment.

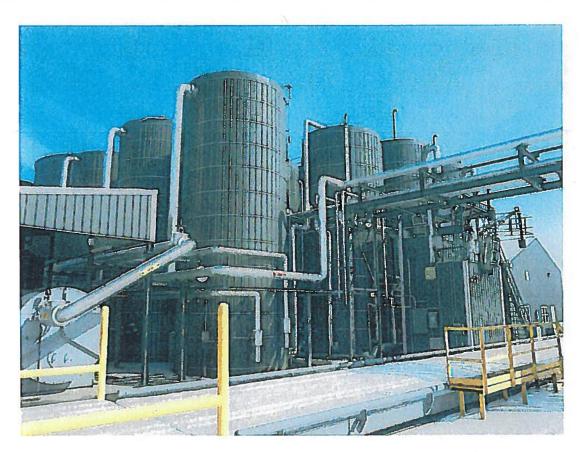
Photo: #3 Site: Coastal Energy Corp., Willow Springs, MO Date: 2/10/2014 Time: AM Direction: Northeast Photographer: Paul Doherty, EPA Witness: Heath Smith, EPA Description: Ten 30,000 gallon asphalt tanks not contained within sized secondary containment.

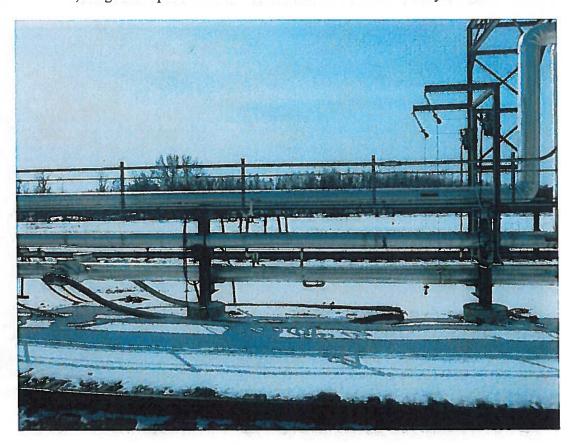
Photo: # 4 Site: Coastal Energy Corp., Willow Springs, MO
Direction: South west Photographer: Paul Doherty, EPA
Description: Railcar loading rack lacks sized secondary containment.

Date: 2/10/2014 Time: AM Witness: Heath Smith, EPA

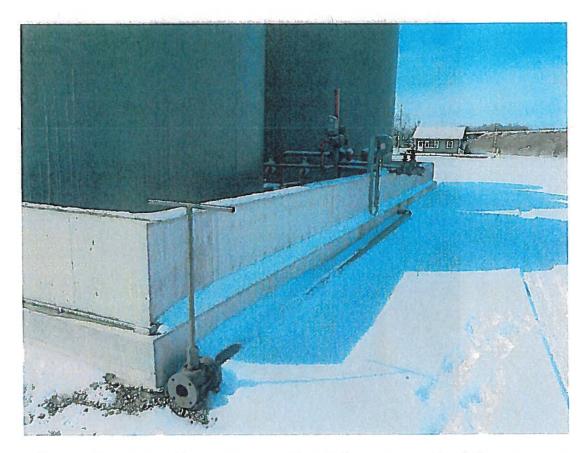
Photo: # 5 Site: Coastal Energy Corp., Willow Springs, MO Date: 2/10/2014 Time: AM Direction: Northwest Photographer: Paul Doherty, EPA Witness: Heath Smith, EPA Description: View of secondary containment around ethanol tanks and drainage control valve out of containment.

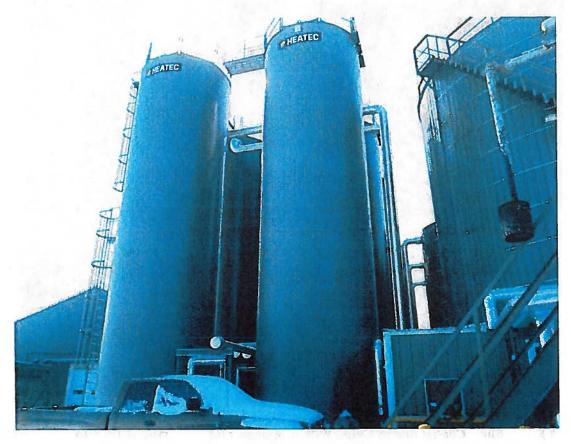
Photo: # 6 Site: Coastal Energy Corp., Willow Springs, MO Date: 2/10/2014 Time: AM Direction: Southeast Photographer: Paul Doherty, EPA Witness: Heath Smith, EPA Description: View of 30,000 gallon liquid asphalt tanks.

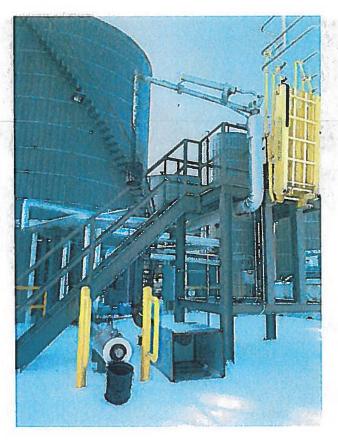
Photo: # 7 Site: Coastal Energy Corp., Willow Springs, MO Date: 2/10/2014 Time: AM Direction: Southwest Photographer: Paul Doherty, EPA Witness: Heath Smith, EPA Description: Tank truck loading rack lacks sized secondary containment.

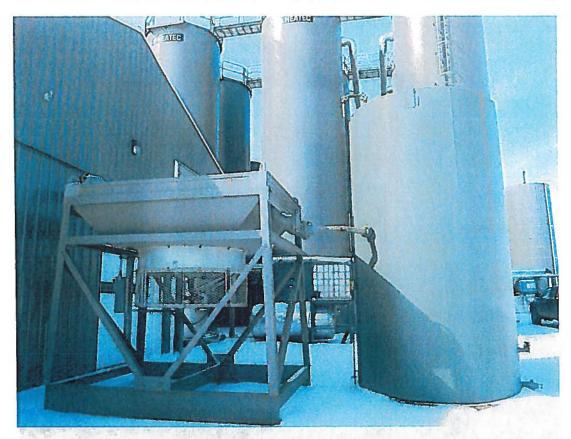
Photo: #8 Site: Coastal Energy Corp., Willow Springs, MO Date: 2/10/2014 Time: AM Direction: West Photographer: Paul Doherty, EPA Witness: Heath Smith, EPA

Description: View of oil water separator without sized secondary containment.

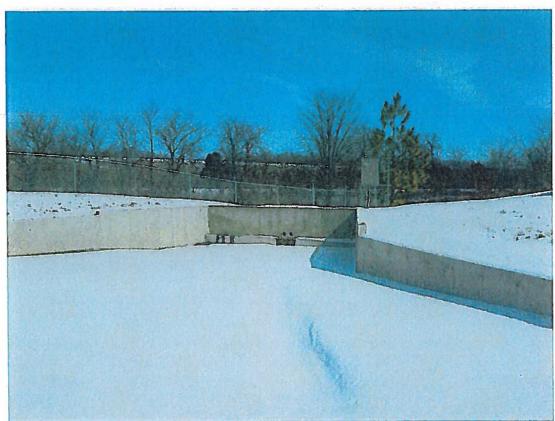
Photo: #9 Site: Coastal Energy Corp., Willow Springs, MO Date: 2/10/2014 Time: AM Direction: Northeast Photographer: Paul Doherty, EPA Witness: Heath Smith, EPA Description: View of general secondary containment outlet that has since been closed by order of the state. Accumulated water is automatically pumped via a float activated pump to an open field south of the tank farm under permit from the state without prior visual inspection. This drainage control practice is not addressed in the SPCC plan.

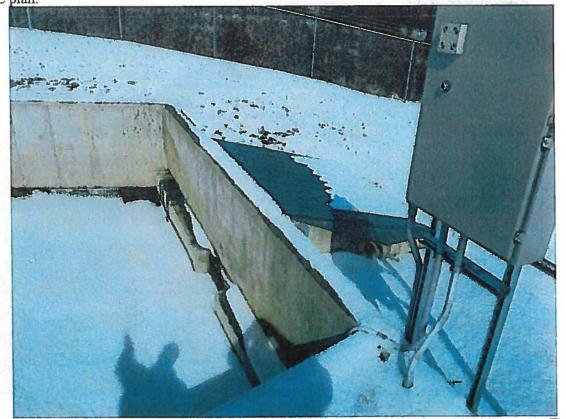
Photo: #10 Site: Coastal Energy Corp., Willow Springs, MO Date: 2/10/2014 Time: AM Direction: North Photographer: Paul Doherty, EPA Witness: Heath Smith, EPA Description: View of former drainage outlet now acting as a sump pit for drainage control and general secondary containment.

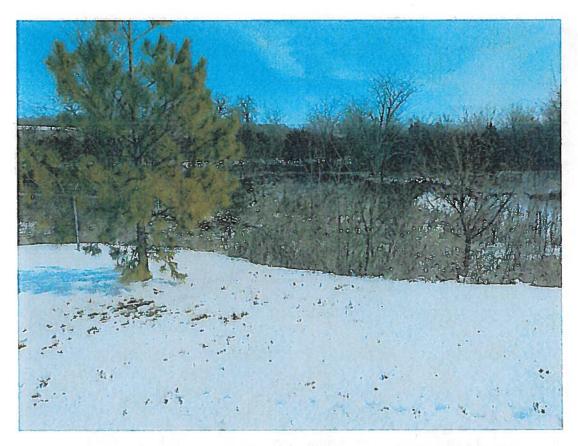
Photo: #11 Site: Coastal Energy Corp., Willow Springs, MO Date: 2/10/2014 Time: AM Direction: North Photographer: Paul Doherty, EPA Witness: Heath Smith, EPA Description: View of the headwaters of the Eleven Point River, a nationally designated wild and scenic river.

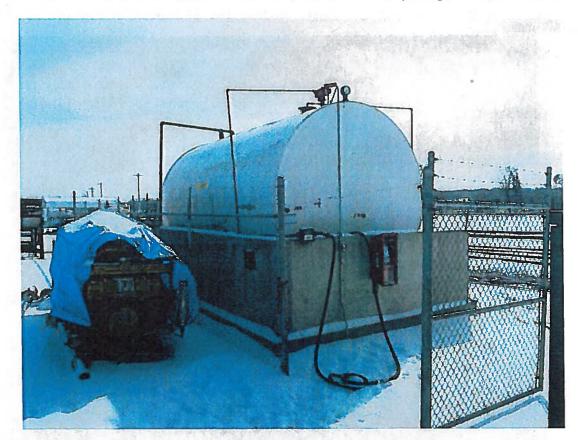
Photo: # 12 Site: Coastal Energy Corp., Willow Springs, MO Date: 2/10/2014 Time: AM Direction: Southeast Photographer: Paul Doherty, EPA Witness: Heath Smith, EPA Description: View of 10,000 gallon fuel tank within secondary containment.
